## Marti Tunnel Conveyor with two Boosters keeps the “Metrô São Paulo” in Brazil on the Move

# Tunnel conveyor with two boosters for use in loose rock

Client: Consórcio Metropolitano 5  
Total value of order: 3.5 million USD  
Created: 2013 – 2015

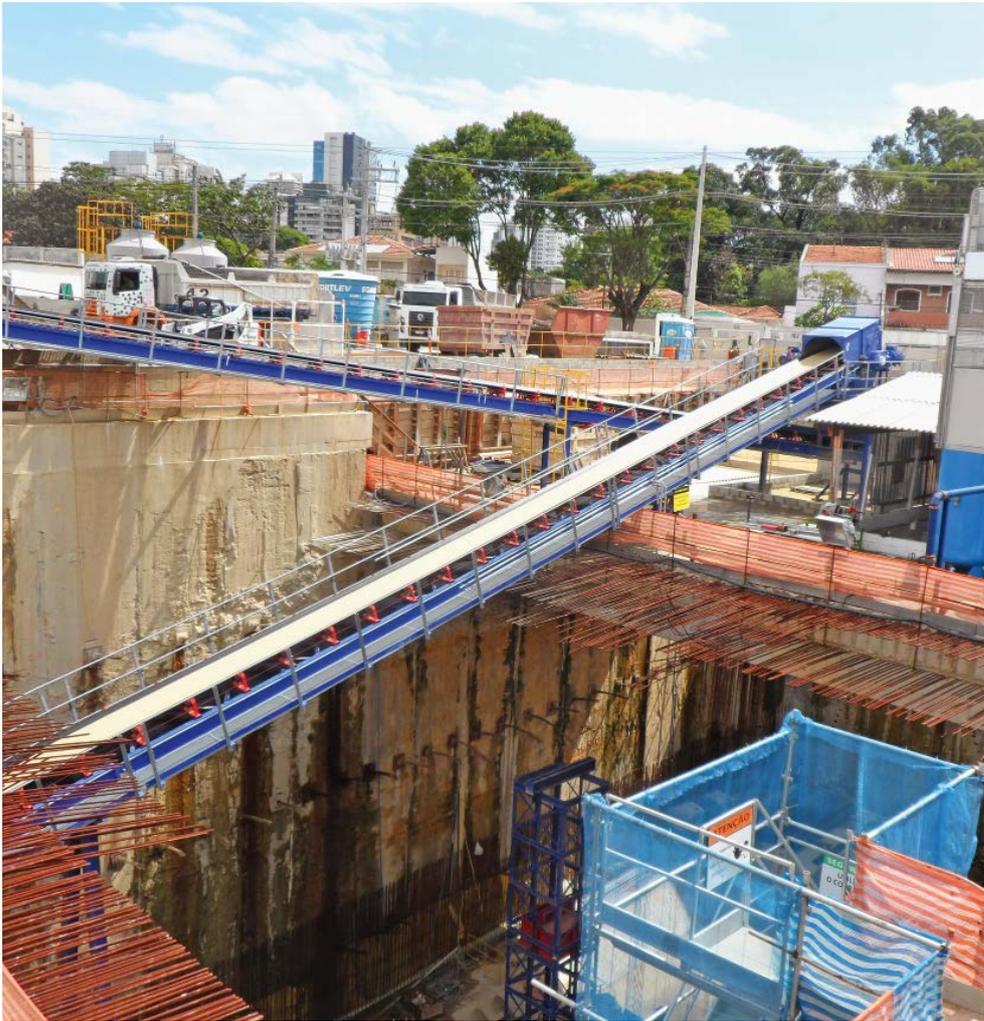
The 5.7 km length of the tunnel may not break any records, but the section has its share of technical challenges. For one, there are several curves to be overcome. Also, owing to the loose rock present, the machine operates with an Earth Pressure Balance Shield (EPB). This means that the machine supports the advance face with the pressure of the spoil in the excavation space. To maintain this pressure constantly at the required intensity, the spoil is partially liquefied and treated with chemical additives. The liquefaction and the use of additives make the material to be removed stick together. As a result, this viscous material is difficult to transport on the ascending conveyor. During planning and construction we had to consider these circumstances and create an installation which could work without problems despite the difficulty of the task.
